# **INDOOR AIR QUALITY ASSESSMENT**

**Department of Children and Families  
140 High Street  
5<sup>th</sup> Floor  
Springfield, Massachusetts**

Prepared by:  
Massachusetts Department of Public Health  
Bureau of Environmental Health  
Indoor Air Quality Program  
July 2019

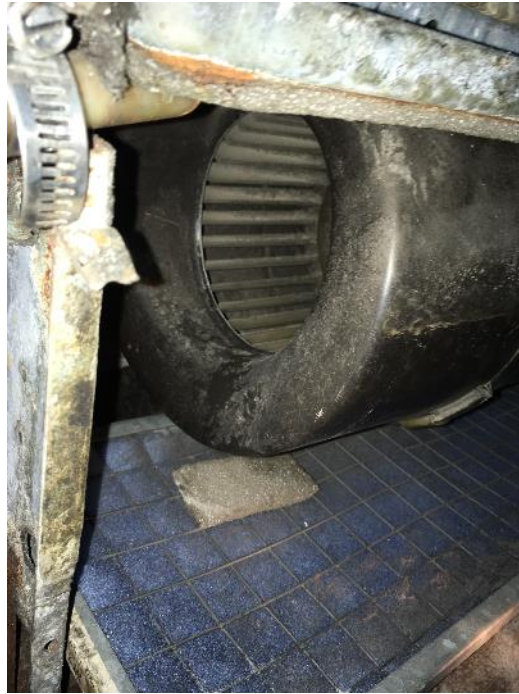
**Picture 1**

Of note is the type of air filters used in the FCUs. Instead of manufactured filters with cardboard frames, each unit has a wire frame device with filter material that is cut by hand (Picture 1). These filters provide minimal filtration. The dust spot efficiency is the ability of a filter to remove particulate matter of a certain diameter from air passing through the filter. ASHRAE indicates that filters with a dust spot efficiency of a minimum of 40 percent would be sufficient to reduce many airborne particulates (Thornburg, 2000; MEHRC, 1997; ASHRAE, 1992). Pleated filters with a minimum efficiency reporting value (MERV) dust-spot efficiency of 8 or higher are recommended to filter out pollen and mold spores. Consideration should be given to installing pleated filters. Note that increasing filtration may require evaluation and adjustments to the FCUs to manage increased flow resistance created from using higher MERV value filters.

**Hand-cut filters in wire rack**

2. Replace hand-cut filters with cardboard framed filters of the correct size.
3. Replace filters at least twice a year.
4. Seal all spaces/holes in FCU cabinets above the filter rack with aluminum refrigerator tape.

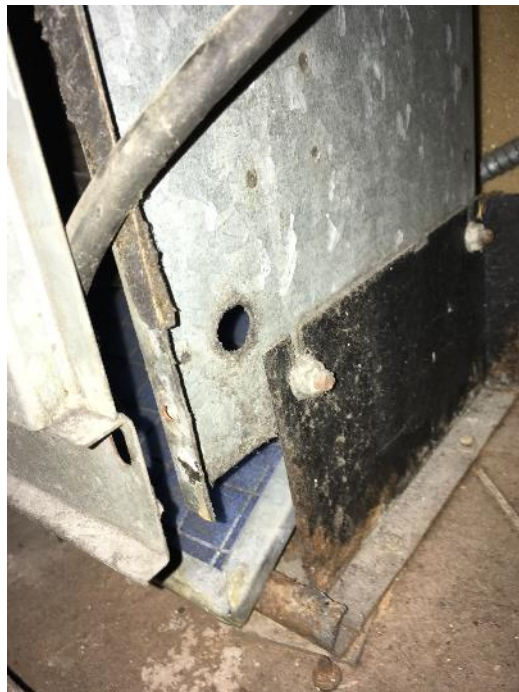
**Picture 2**

The FCU cabinets also have openings above the filter system (Picture 2). These opening allow unfiltered air from wall cavities to be drawn into the unit to become aerosolized.

**Hole in FCU cabinet above filter that allows particles to by-pass filtrations**

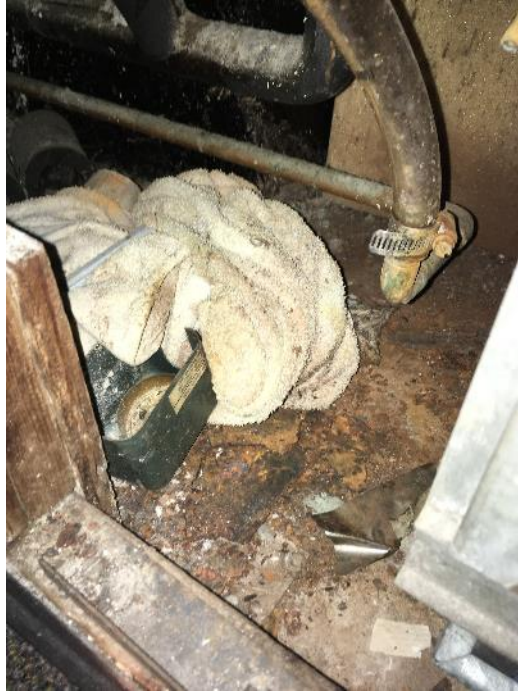
**Picture 3**

Substantial amounts of accumulated dirt and debris were noted in the interior of FCUs. Towels used to absorb water from a pipe leak were found in one unit (Picture 3). These can become colonized with mold when chronically moistened and be attractive to pests.

**Towel inside wall cavity (note signs of water leakage and corrosion)**

5. Have the interior of all FCUs cleaned by an HVAC service company.
6. Remove all debris and items (e.g., towels) used to absorb leaking water.
7. For buildings in New England, periods of low relative humidity during the winter are often unavoidable. Therefore, scrupulous cleaning practices should be adopted to minimize common indoor air contaminants whose irritant effects can be enhanced when the relative humidity is low. To control for dusts, a high efficiency particulate arrestance (HEPA) filter equipped vacuum cleaner in conjunction with wet wiping of all surfaces is recommended. Drinking water during the day can help ease some symptoms associated with a dry environment (throat and sinus irritations).

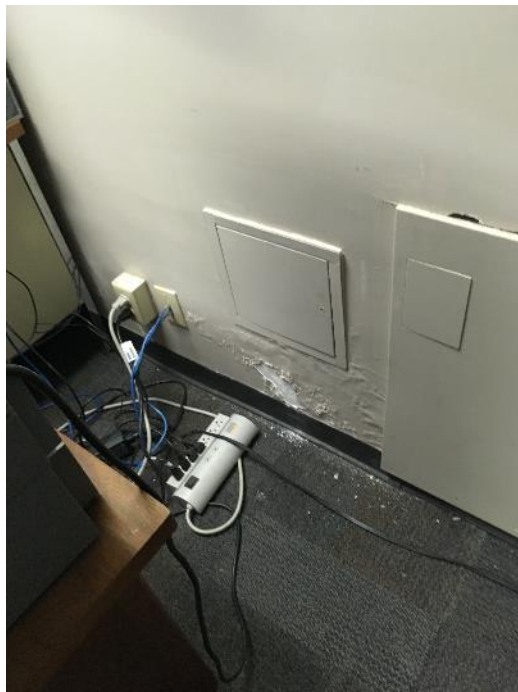
**Picture 4**

Plaster walls in the office have water damage that appears to be due to leaks from heat system pipes, as shown by:

**Water damaged plaster beneath inspection door**

1. Have the existing ventilation/heating system evaluated by an engineer with experience in this type of HVAC system to determine the cause of water-damaged plaster walls. Such an individual should consider the feasibility of such repair as well as the ability of the existing HVAC system to operate in a manner to maintain occupant comfort.

2. In order to examine and repair the water leaks, it is likely that portions of plaster walls would have to be removed. In order to prevent impact on building occupants, it is highly recommended that any evaluation be done in a manner in accordance with the EPA guideline “Mold Remediation in Schools and Commercial Buildings” (US EPA, 2008).
3. Prior to any demolition of plaster walls, it is highly recommended that the wall material be tested for the presence of asbestos in a manner consistent with federal and Massachusetts statutes and regulations.

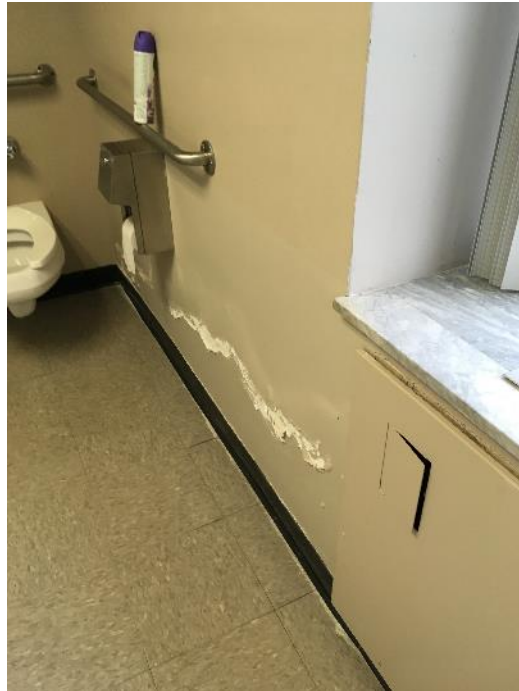
**Picture 5**

**Damaged plaster in a straight line on a wall not directly beneath a window**

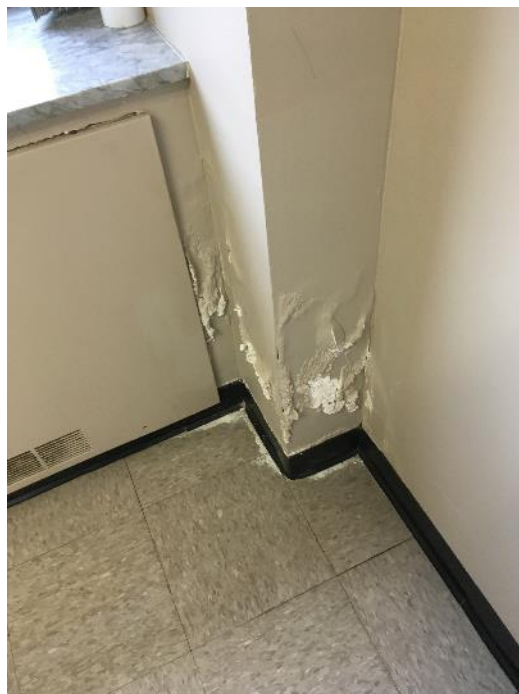
**Picture 6**

**Damage at a corner where heating system pipe elbow joints likely exist**

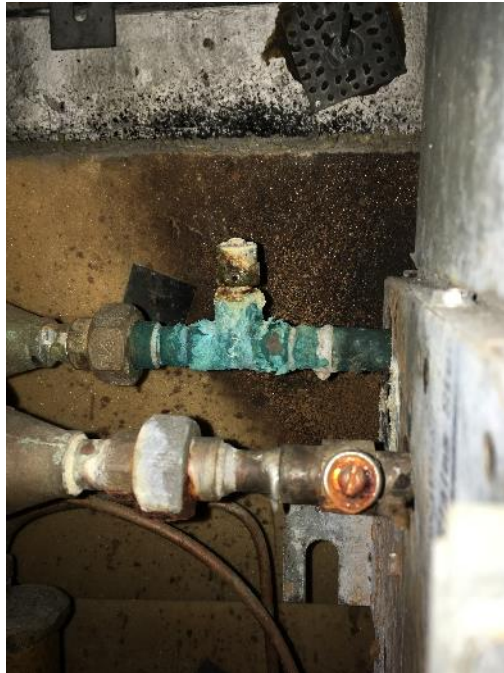
**Picture 7**

Evidence of water spaying the interior of the wall cavity was noted (Picture 7). Water from heating pipes can have a metallic odor that can be irritating to the eyes, nose and throat. Despite this, no visible mold growth or associated odors were observed. Additionally, a number of areas had water-damaged ceiling tiles (Table 1).

**Evidence of water spraying the interior of the wall cavity  
(Note corrosion and water bead on valve as well as wall discoloration behind valve)**

9. Repair all leaking pipe valves for the HVAC system that do not require the demolition of plaster walls.
10. Discontinue the use of fragrance diffusers.
